Water Resources Report No. 55

The Hydrology of Maramec Spring

THE HYDROLOGY OF MARAMEC SPRING

James E. Vandike

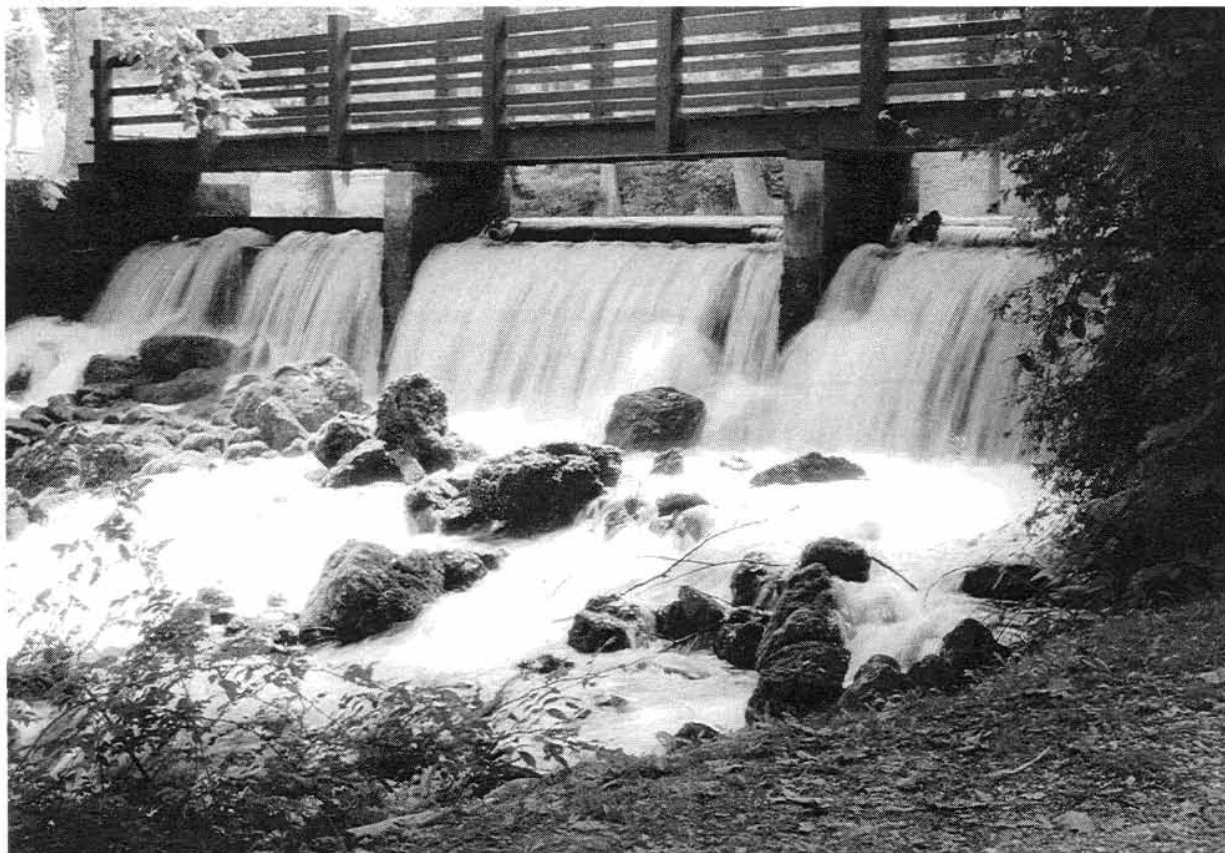
Figure 2. This scenic waterfall at Maramec Spring was the site of an undershot water wheel that helped power the Maramec Iron Works. Photo by Jim Vandike.

When the Maramec Iron Works was in full production, the spring provided nearly all of the power that could not be supplied by the muscles of the men who labored there. James constructed several low dams eight to 10 ft high to increase the height or head potential of the water (figure 2). Water power potential depends on two factors—volume of flow and the height that the water can fall. Water discharging from a spring the size of Maramec, even with only a few feet of fall, can supply many horsepower of energy, and more than enough to run the iron works for 50 years. A large undershot water wheel powered a high-volume, low-pressure air compressor that fed the furnace fire. The same water passed through smaller wheels to power the giant trip hammers that were used to forge the impurities from the pig iron, and convert it to wrought iron. The water also powered a grist mill that ground grain for

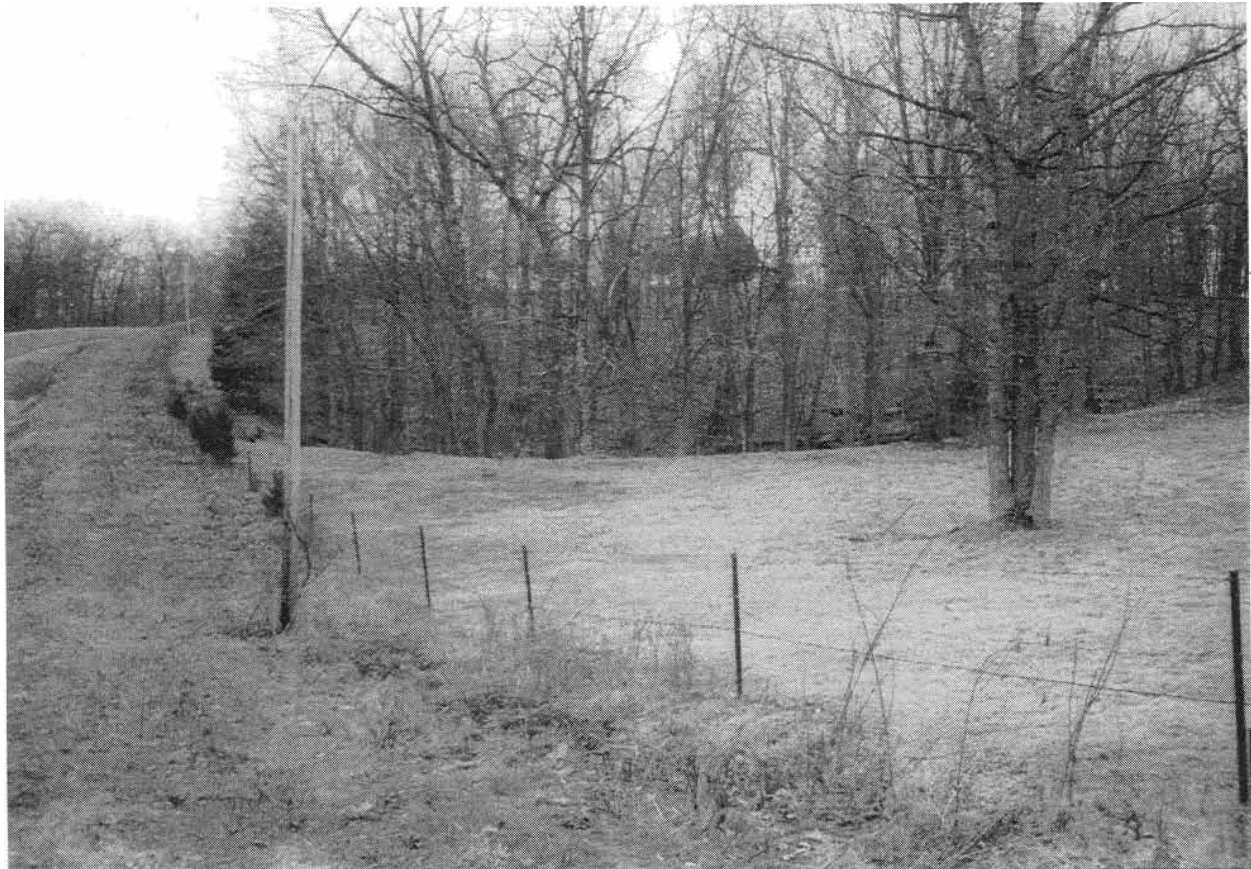
Figure 9. Photograph of a large sinkhole in Dry Fork basin. Photo by Jim Vandike.

Discrete recharge occurs only where there are specific geologic features that allow large quantities of water to enter the subsurface with little resistance, predominately in sinkholes and losing streams. Sinkholes are bowl-shaped, topographic depressions in the Earth's surface that formed by the dissolving of bedrock and the subsurface removal of soil and rock (figure 9). Sinkholes act as natural funnels. Runoff from precipitation that enters them is channeled directly into the subsurface through relatively large openings.

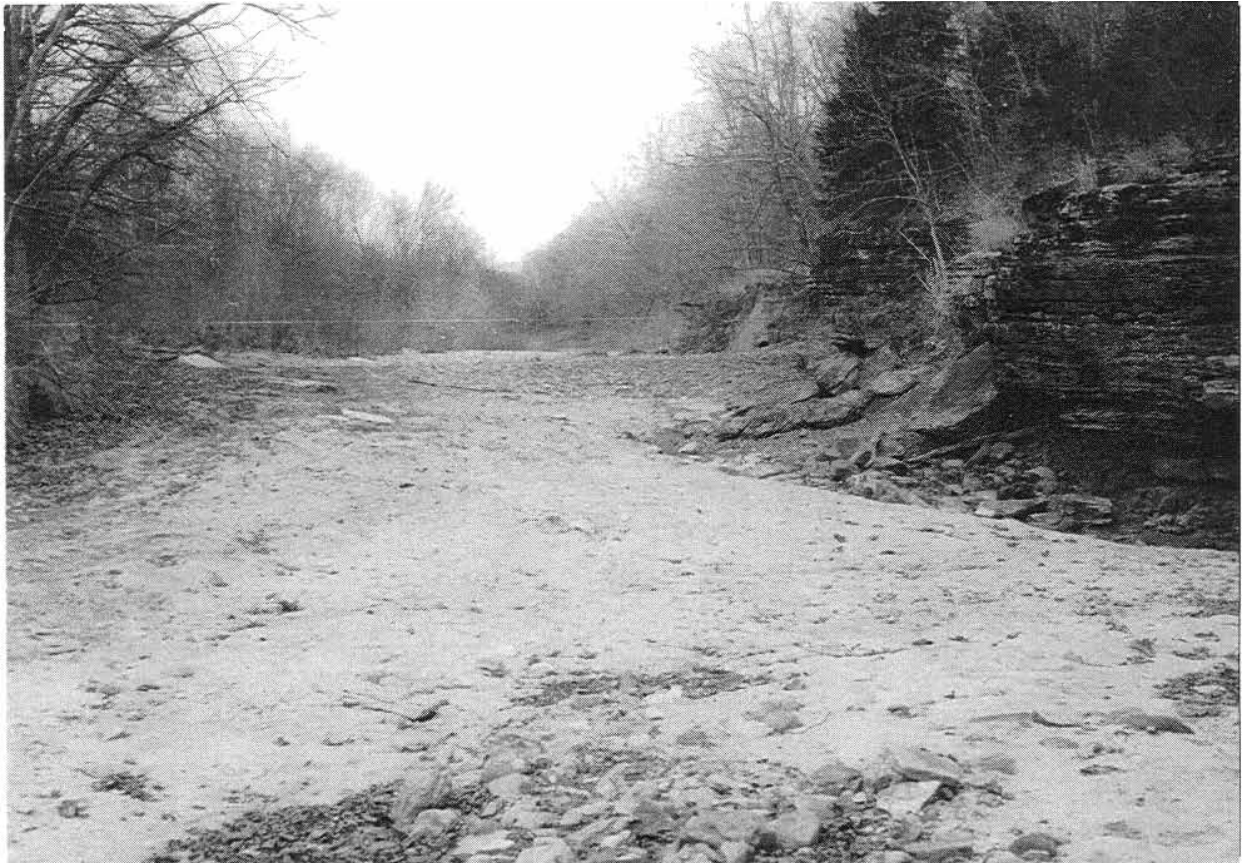
Figure 10. Photograph of a losing reach of Dry Fork at Phelps County Road 4080 (formerly Spring Hill Road). Photo by Jim Vandike.

Losing streams, like other karst features, are the result of the dissolution of the carbonate bedrock. They are a result of the weathering, not the cause of it. Losing streams can be identified several ways such as by the loss of flow from the stream, by the characteristics of the alluvial materials in the streambed, by vegetation types, and other factors. Losing streams are subsurface drainage features. Water levels in the aquifer are generally lowest along losing stream reaches, and adjacent to the conduits that channel water from losing streams to springs. Thus, water in the aquifer moves toward the conduit, not away from it. Since the conduits serve as drains for the

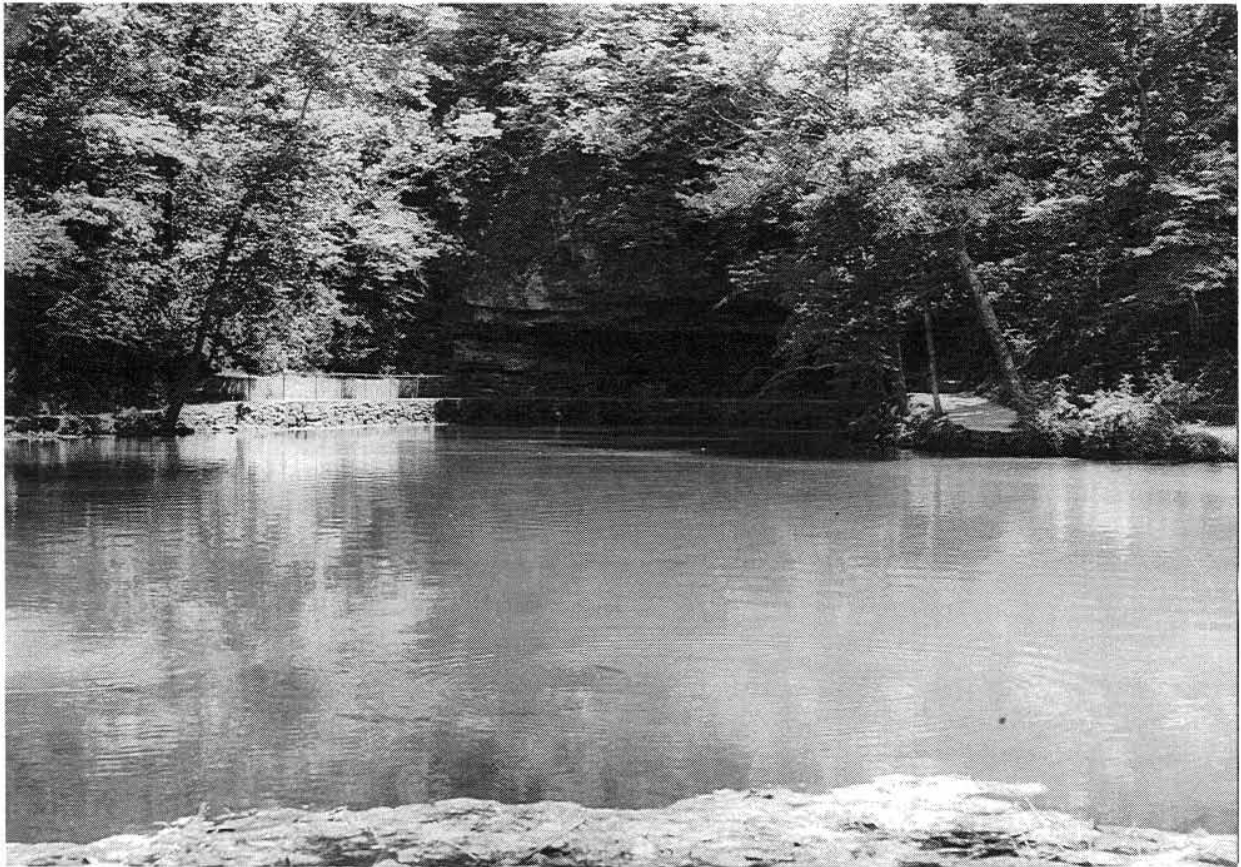
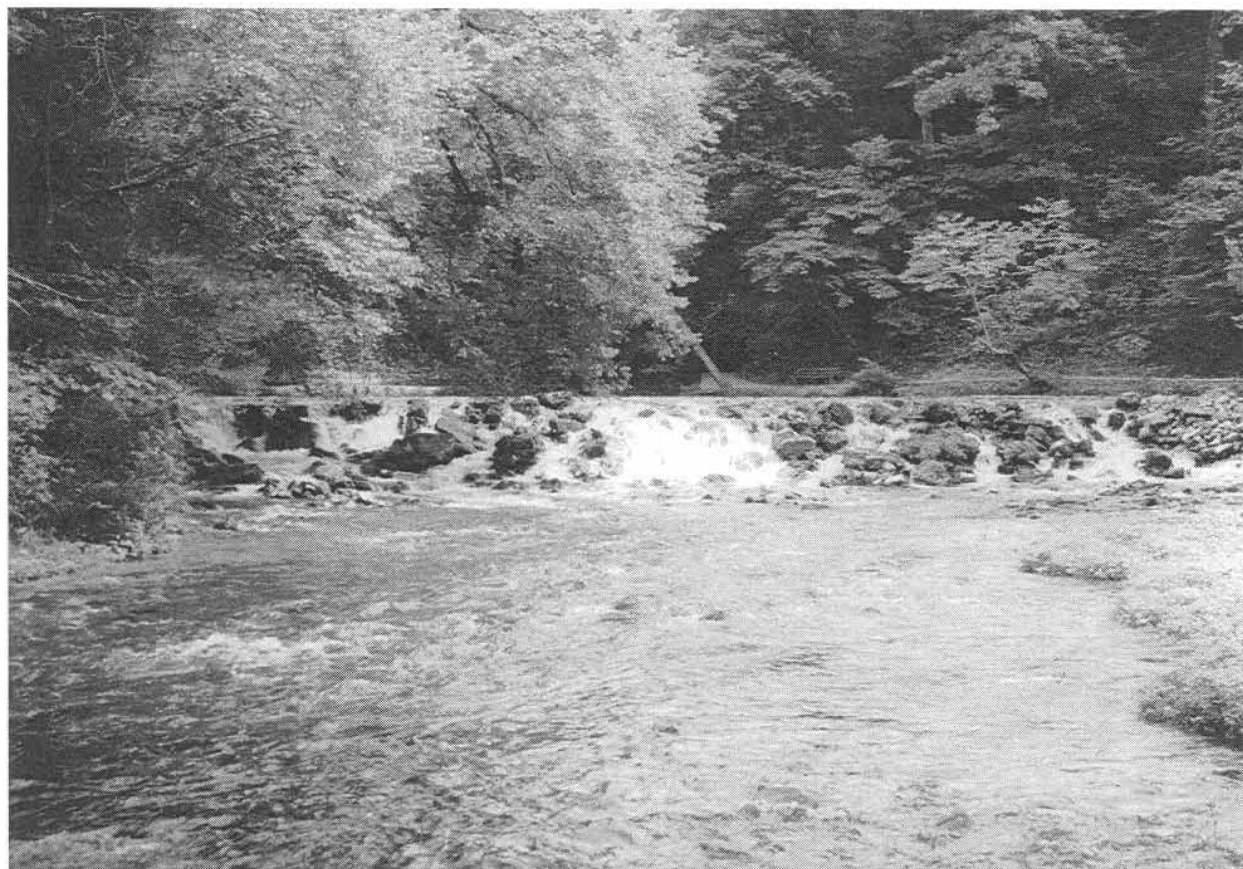
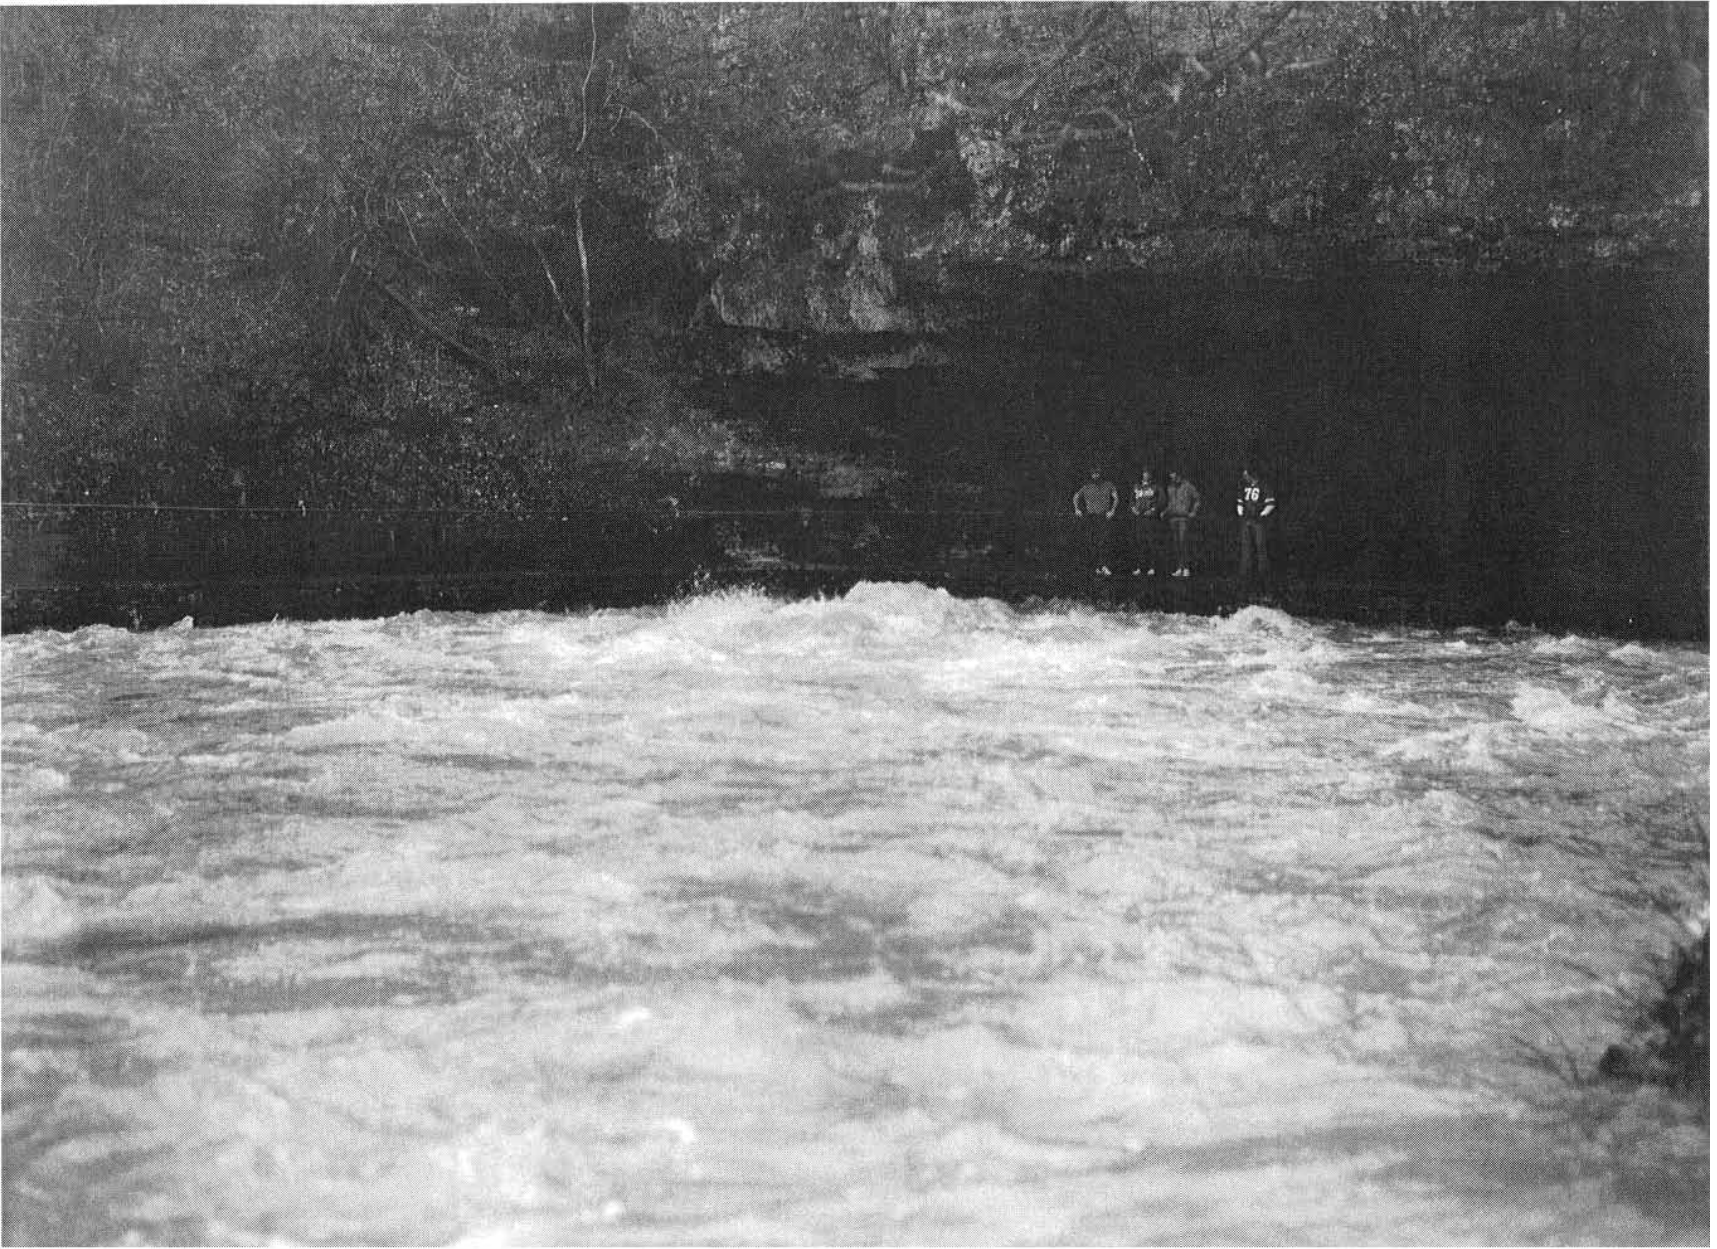
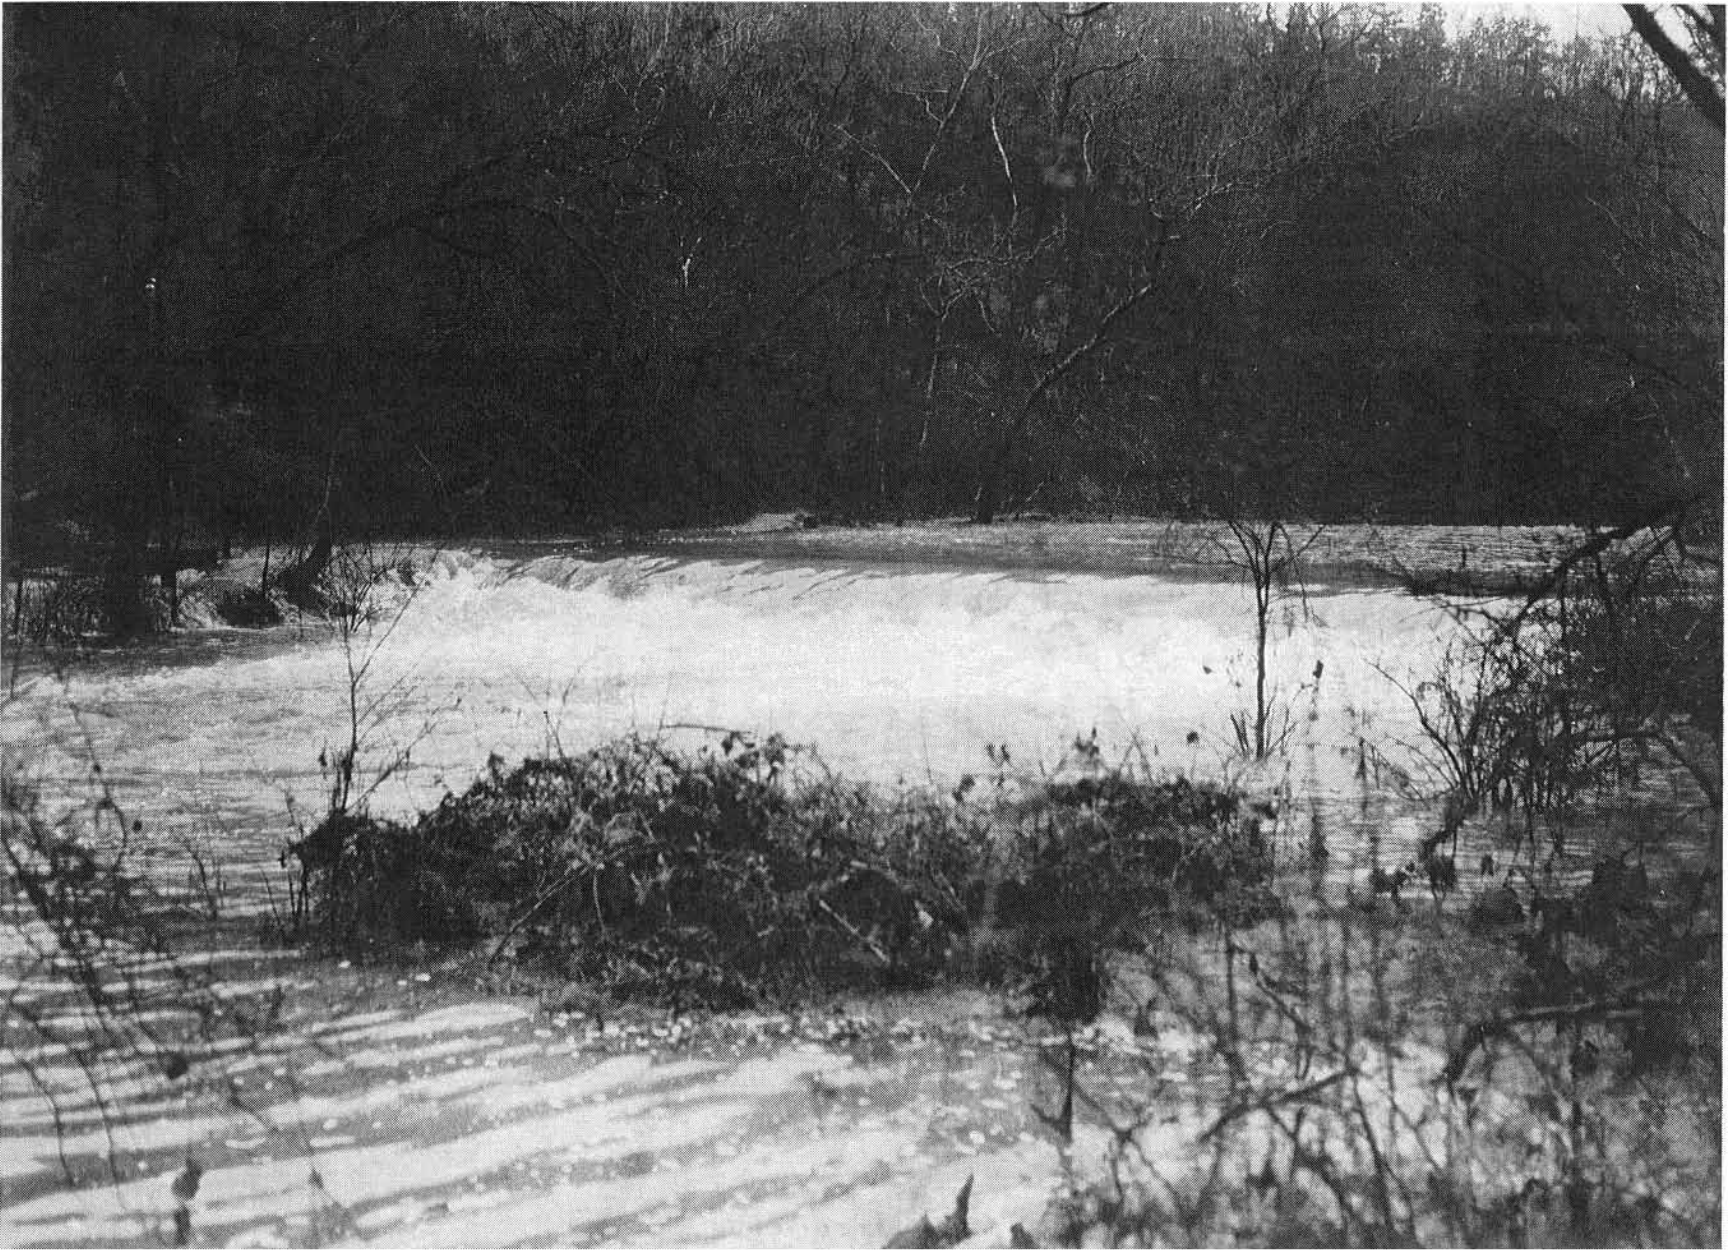
Figure 11a-11d. Photographs showing Maramec Spring rise pool and dam during low flow and high flow conditions. Photos by Jim Vandike.

graphs in figure 11 illustrate the differences between the spring during relatively low and very high flow conditions. During low-flow periods, the water surface in the rise pool above the spring outlet is calm, and boulders in the rock dams are exposed (figures 11a and 11b). The photographs shown in Figure 11c and 11d were taken December 4, 1982, after two days of very heavy rainfall. Rolla-UMR reported 6.54

inches of rain on December 3 and an additional 1.96 inches on December 4, a total of 8.50 inches during the two days. Salem reported 5.41 inches on December 3, and 1.06 inches on December 4, a total of 6.47 inches. The peak discharge measured by the U.S.G.S. at Maramec Spring in conjunction with this storm was 770 ft³/sec on December 6.

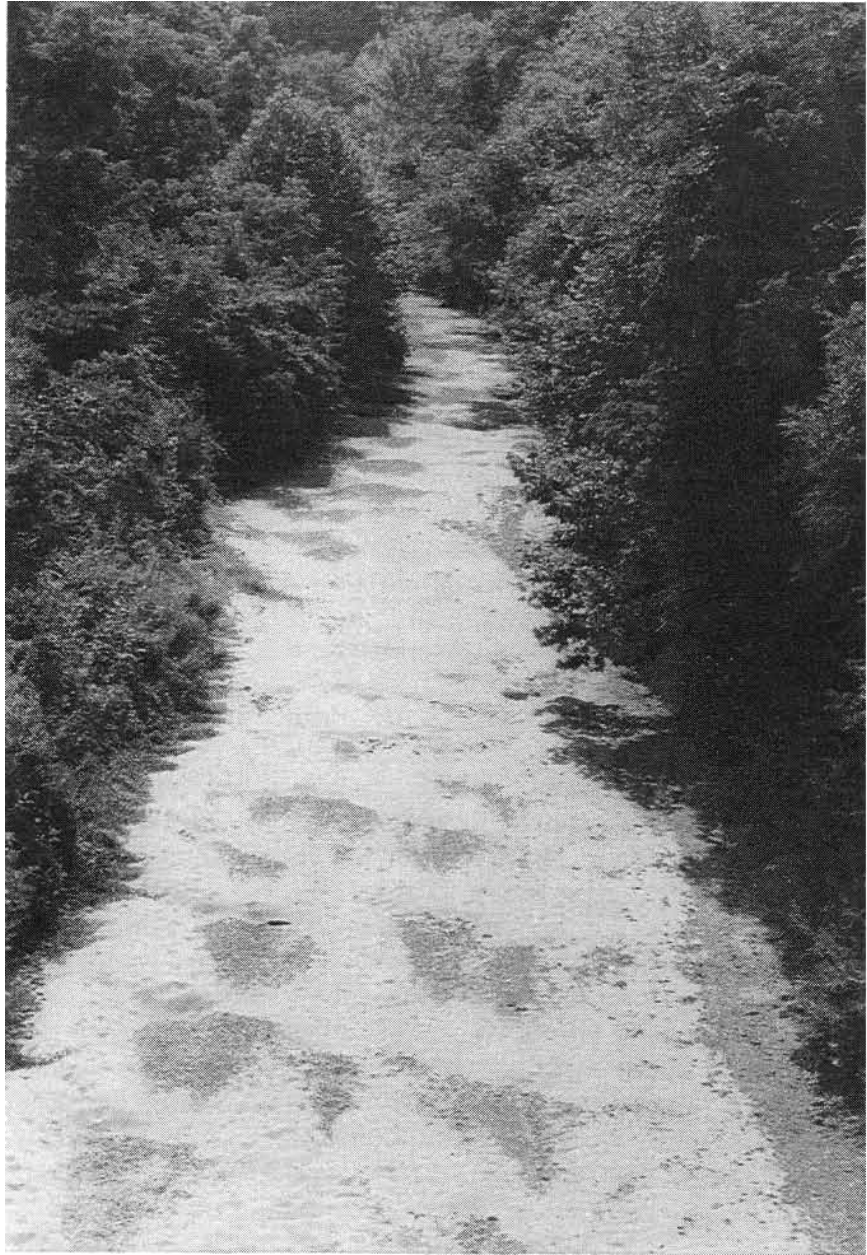
Figure 23. Norman Creek at Phelps County Route F. Photo by Jim Vandike.

During dry weather, the terminal water-loss zone may migrate upstream several miles south of the Phelps-Dent County line as subsurface drainage lowers the water table elevation in the transition area between gaining and losing conditions. In wet weather there may be some flow through

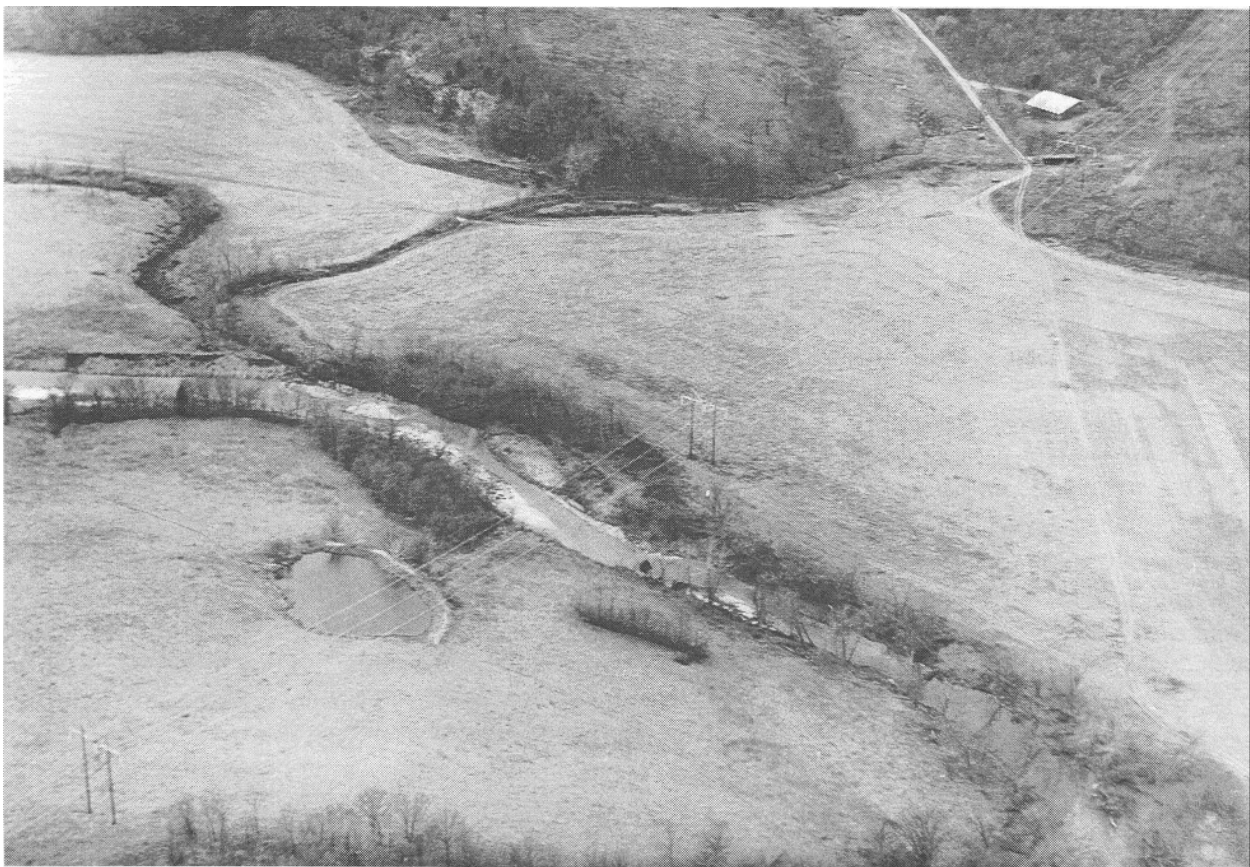
Figure 28. (Top) Topographic map of the 1981 fertilizer pipeline leak. Topography from the Lecomma 7 1/2' quadrangle. (Bottom) Areal Photo of the spill site, looking southwest. Photo by Jim Vandike.
